# DORIC PROPERTY INSPECTIONS

## Confidential Inspection Report 5/2 Newlands Road Warwick NSW

April 26, 2018

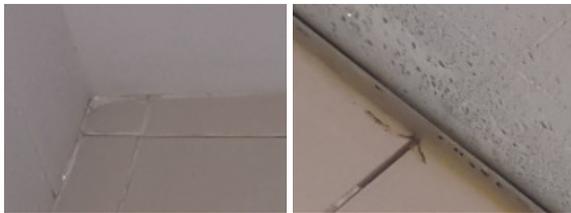
The floor tiles are cracked and drummy within the shower recess possibly requiring maintenance/ replacement.

There is silicon within the shower recess which may be a temporary waterproofing repair, requiring maintenance repairs/ replacement carrying out due to damage waterproofing membrane.

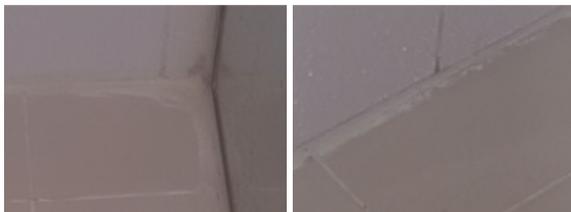
The floor tiles are drummy within the shower recess possibly requiring maintenance/ replacement.

As per the bathroom; there is silicon within the shower recess which may be a temporary waterproofing repair.
