# DORIC PROPERTY INSPECTIONS

## Confidential Inspection Report 22 Bates Avenue Cronulla NSW

January 23<sup>rd</sup> 2019

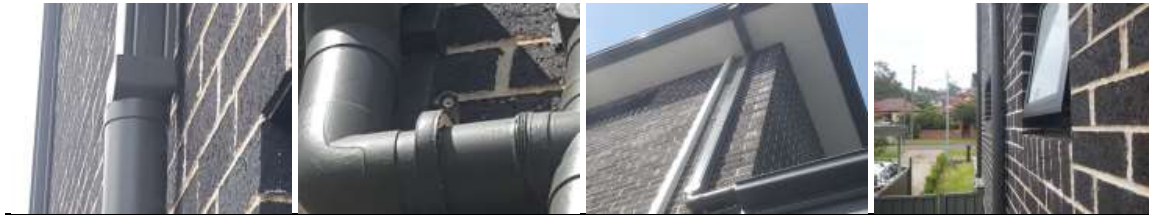
The down piping is loose and requires securing to the building.

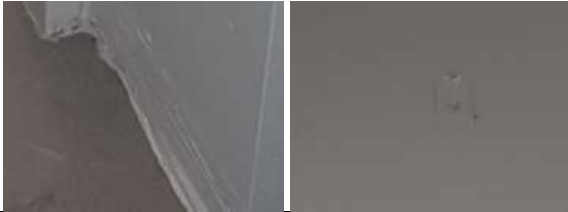
Wall Finishes

The walls have unsightly finishes visible, which will require repairs carrying out.

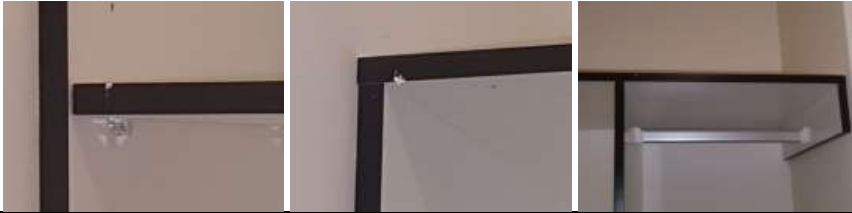
*Joinery*

The robe was tested and was in working order however is out of level requiring removal and replacement.

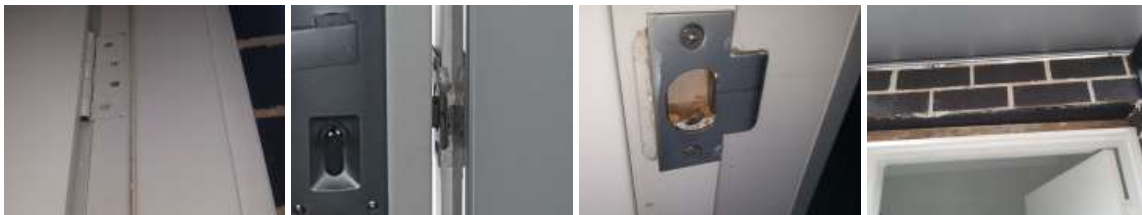
*Door/S*

The door was tested and was in working order on inspection. The external door was tested and was in working order however it is ill fitting. The external door was tested and was in working order however the hardware is incomplete (The frame is also incomplete to the top of the door, requiring a fascia/ architrave fitting).

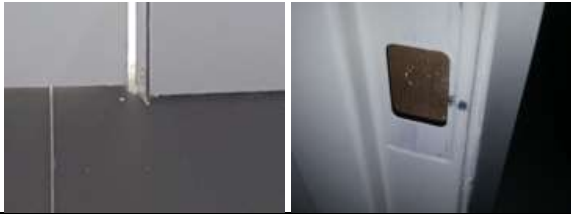
*Door/S*

The door was tested and was in working order however it is ill fitting and the hardware is incomplete.

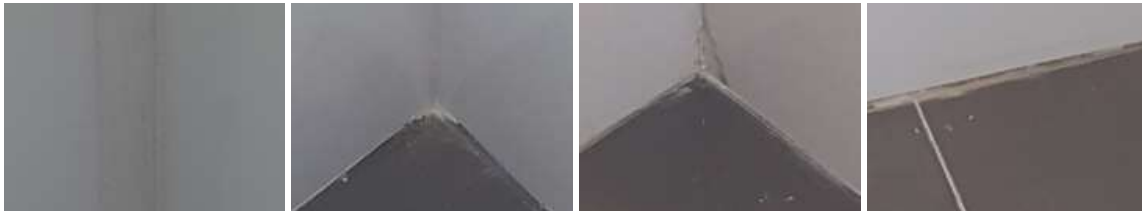
Floor And Wall Tiles

The tiles are in poor condition with unsightly grout and loose tiling

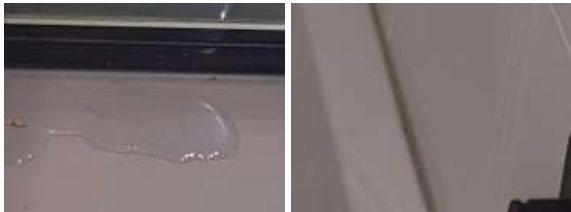
Shower/Bath Condition

The shower recess was tested and found to be leaking.

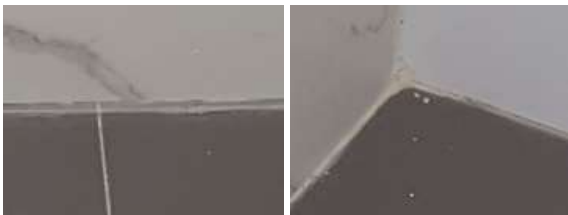
*Floor And Wall Tiles*

There is a large amount of grout within the internal corners of the tiles which may be covering up cracked tile joints.

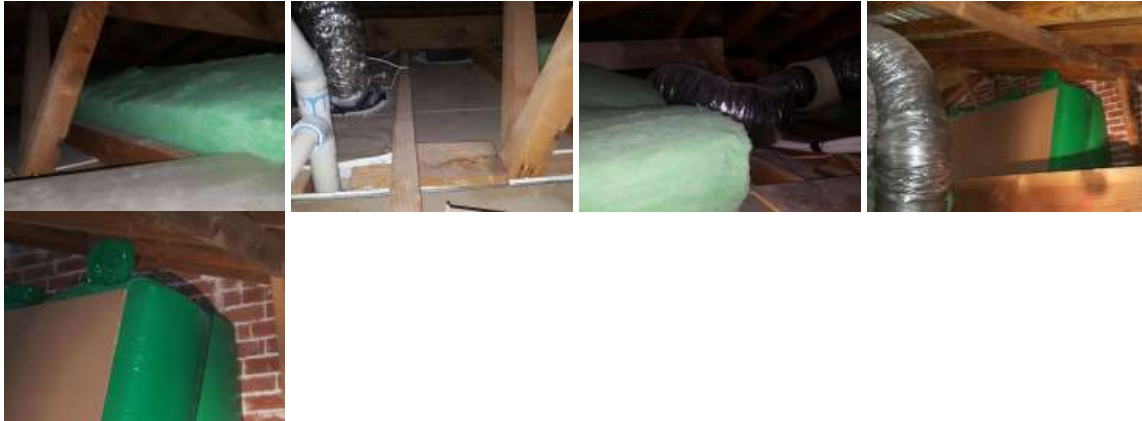
Builders debris has been left within the roof void covering the ceiling and ceiling members; preventing a full inspection of this area. Full bales of insulation, sheet flooring, sheets of MDF and stored goods has been placed over some ceiling and ceiling timbers, which prevented the inspection of those covered areas and timbers.

Ductwork and insulation is present in the roof cavity; this restricted inspection to the roof and ceiling timbers and removal of insulation or ductwork is not within the scope of a standard visual building inspection report.

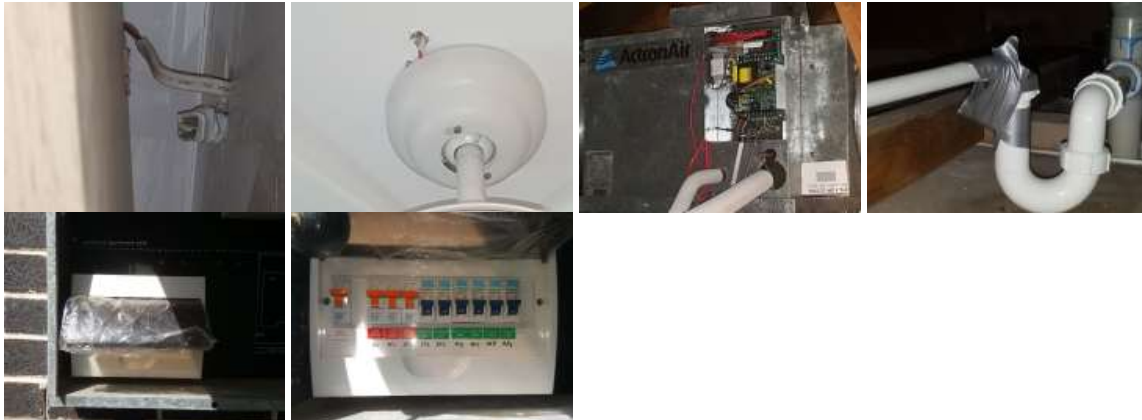
The evaluation of air-conditioning is not part of a standard pre purchaser building inspection report and is the subject of a special purpose report. We recommend this be carried out by a specialist in air-conditioning installation, maintenance and control. The electrical board was in good condition at the time of inspection. Gas is connected to the premises, however, has not been evaluated and should be inspected by a qualified gas fitter. Rainwater tank overflow The wiring to power points and the air conditioning unit within the roof void is suspect and we recommend all electrical/ data systems be inspected by an appropriately qualified tradesperson.
