Doric Property Inspections Pty. Ltd. ABN: 62 087 966 514

Confidential Inspection Report

20 Ridge Street Engadine NSW

June 13, 2019

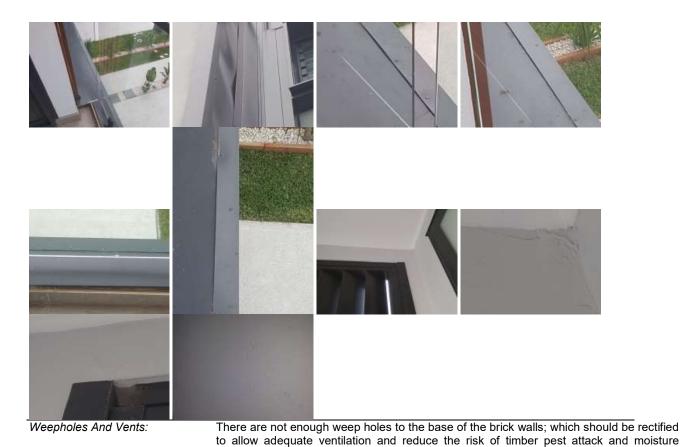
The metal and fibrous cement wall cladding is damaged and inadequately secured requiring the damaged sections removing and replacing/ securing.

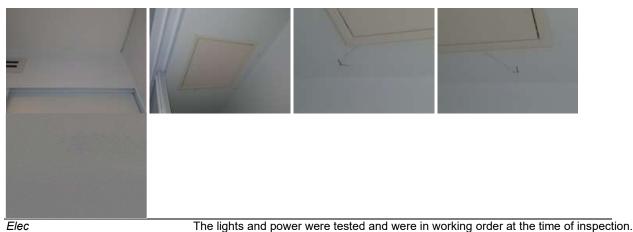
The ceiling appears to have moisture damage visible and is marked requiring repainting.
