DORIC PROPERTY INSPECTIONS

Confidential Inspection Report 2 Bent Street Clyde NSW

May 8, 2019

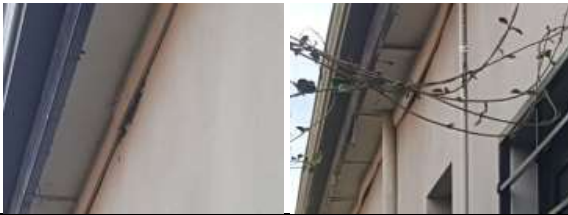
Eaves Type & Condition: Some eave mouldings are sagging; which will require repairs/re fixing.

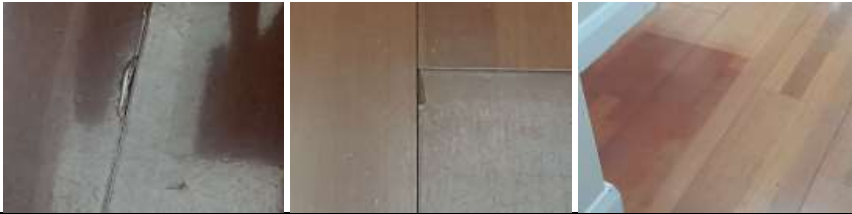
Floor Maintenance The floating flooring is in poor condition with moisture damage and may require replacing.

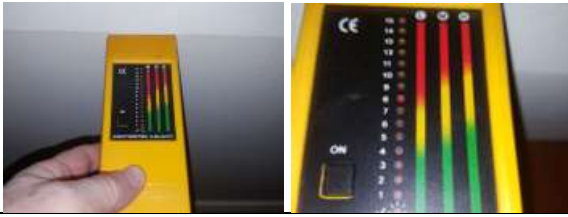
The door was tested and was in working order on inspection.
The floating flooring is in reasonable condition with no major defects visible.
The walls are in reasonable condition with high moisture readings.

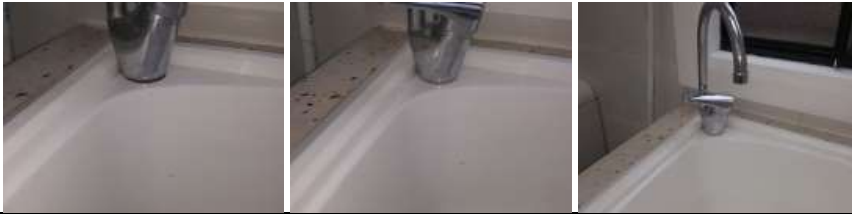
The hot and cold water was tested and both were running clear at the time of inspection. The mixer tap is loose and will require repairs/ replacing.

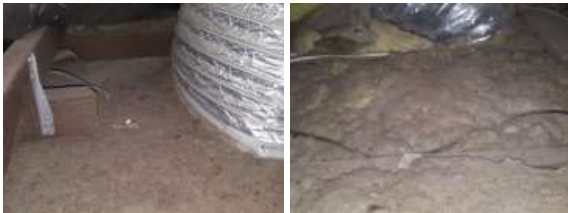
Insulation is not provided to the entire ceiling cavity. Consider the installation of additional insulation.

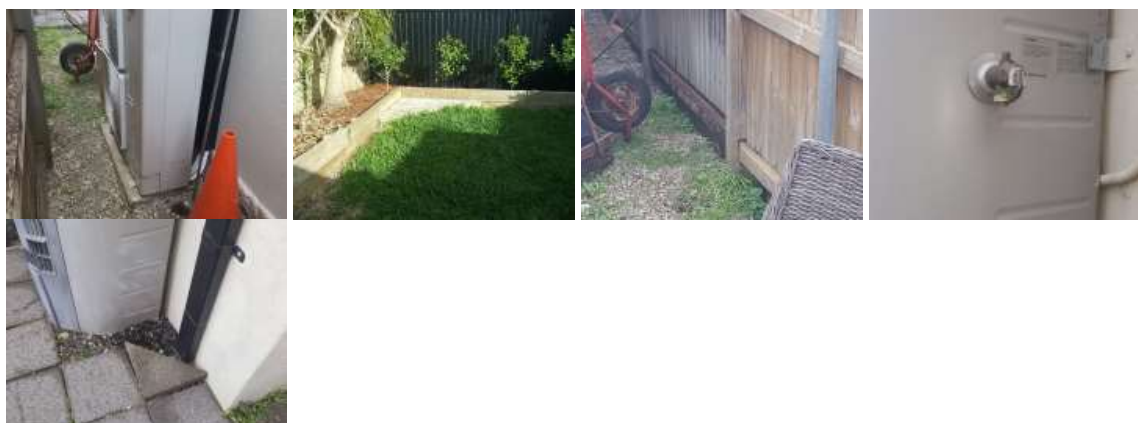
The hot water unit and air conditioning system overflow is discharging moisture adjacent to the structure; we recommend the overflows be situated over a drain. Gardens or soil have been built up against the base of fences in some areas. This build up can conceal current timber pest attack and significantly increases the risk of future attack. Gardens and soil should not be built up against fencing timbers and we recommend modifications be made. Landscaping timbers (including retaining walls) should be replaced with non timber alternative. If replaced with timber, ensure appropriate durability rating for external use.
