DORIC PROPERTY INSPECTIONS

Confidential Inspection Report 11/69 Wharf Street Putney NSW

November 29, 2018

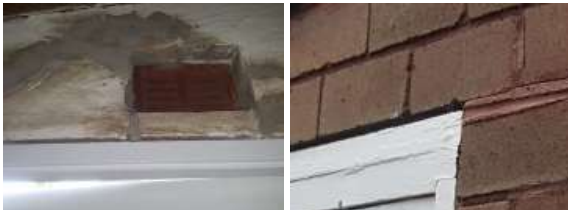
Severe rust is evident to the steel arch bars; which should be replaced. There are also missing arch-ba/s which should be fitted to prevent possible dislodgement of the brickwork.

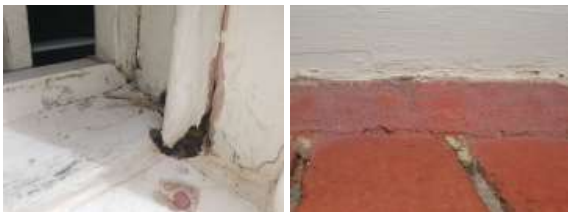
The condition of the exterior windows is generally poor, with severe decay visible to the older frames requiring replacement.

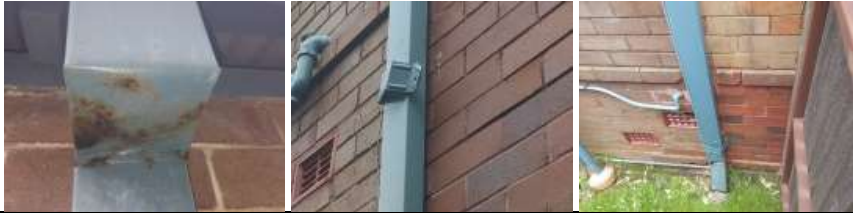
Corrosion is visible to the downpipes which will require replacing. The down piping is loose and requires securing to the building. The down piping is not connected to a legal stormwater dispersal system which should be rectified.

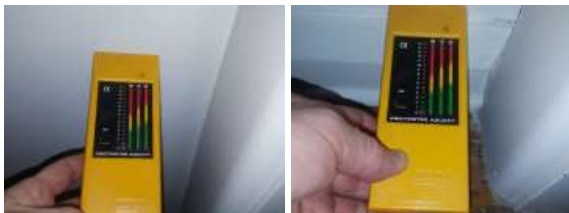
The walls are in reasonable condition with high moisture readings to the side of the bathroom shower recess requiring repairs/ maintenance carrying out.

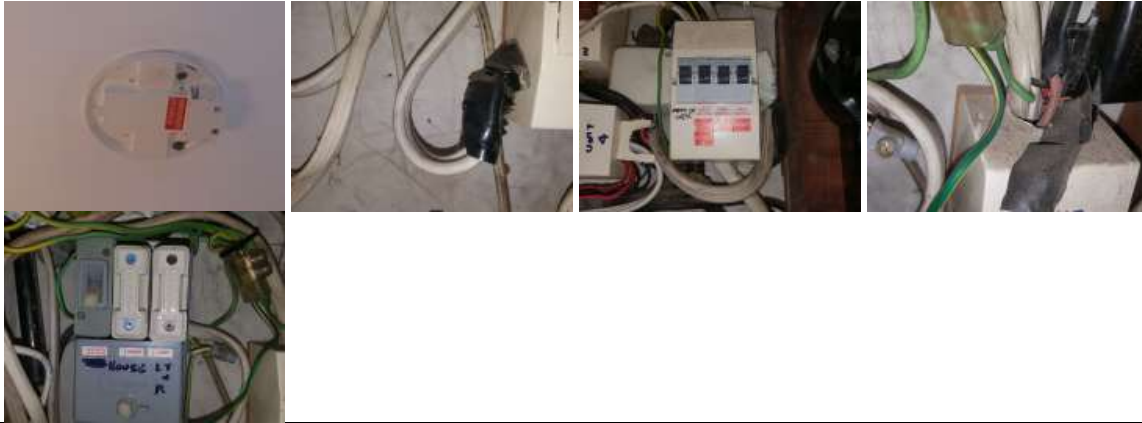
The electrical switch board is old and should be upgraded.
