DORIC PROPERTY INSPECTIONS

Confidential Inspection Report 6/110 Forbes Road Parramatta NSW

June 28, 2019

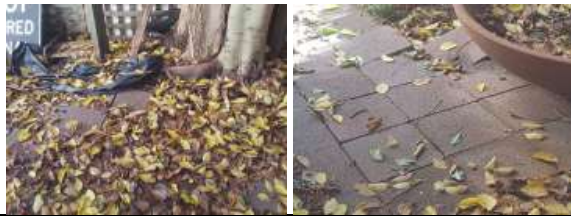
The paths/paved areas are being adversely affected by tree roots. This should be rectified and repairs carried out.

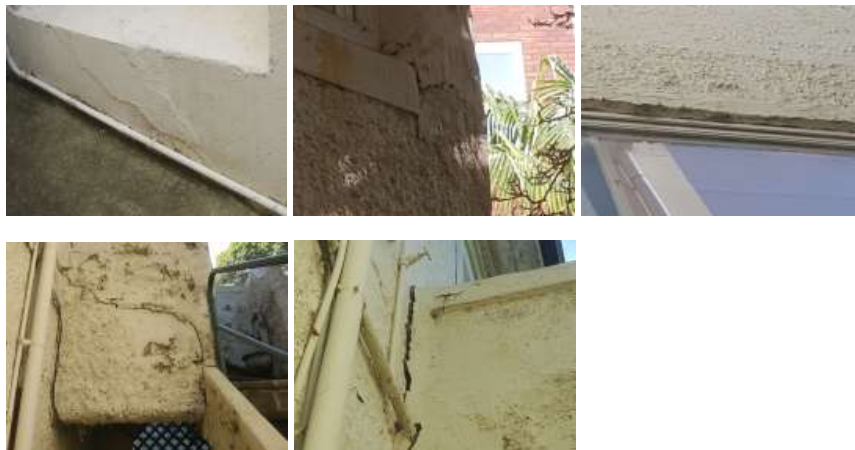
The masonry walls have cracks visible to the render which will require the damaged sections removing and re-applying.

The walls to the front of the building do not appear structurally stable and should be inspected by a structural engineer as a matter of urgency (bottom two photos).

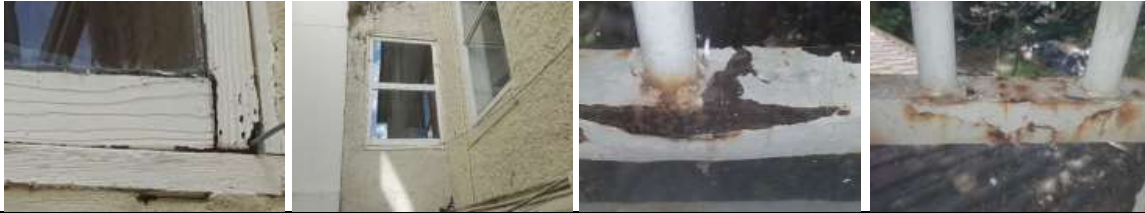
Severe wet rot decay is present to the window frames and damaged timbers will require replacement. Security grill/s are rusted and require repair or replacement.

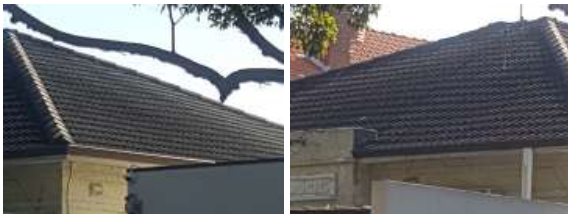
The roof line is undulated requiring access within the roof void.

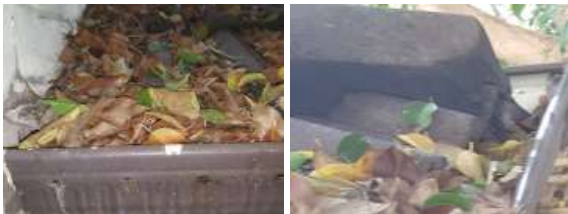
Leaves and debris/ vegetation are present in gutters and the guttering should be cleared and the guttering fitted with leaf guards.

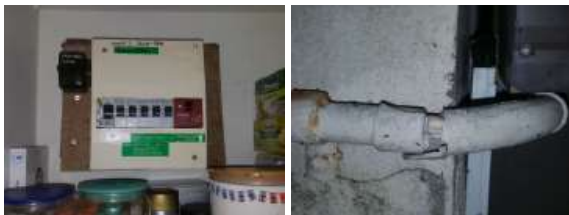
Details: The electrical meter box is in reasonable condition what was visible. The wiring is suspect and we recommend all electrical/ data systems be inspected by an appropriately qualified tradesperson. To the exterior of the building.

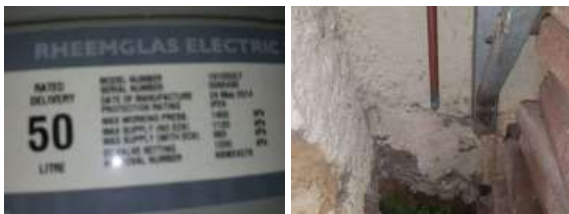
Type/Condition: Mains electric hot water system: Mains pressure: Hot water overflow pipe should be diverted away from the external walls or sub floor area of the house. Damp soil around the building may cause swelling and lead to heaving of structure and cracking to walls. Moisture also encourages termites into the area. We strongly recommend the overflow relief valve be connected to a drainage point.

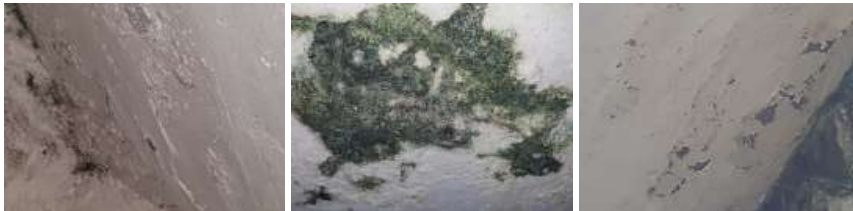
Concrete Damage: There is cracking visible to the underside of the staircase/s which appears to be due to concrete cancer; further advice from a structural engineer is recommended which will require the concrete removing to the face to determine the full extent of the damage and remedial works required.

Due to the unpredictable nature of cracking in building elements it is not possible for the inspector to determine past or future occurrences that have or will impact cracking in this building. Because of these unknowns and the possibility of concealed defects related to cracking in building elements we recommend an engineer be consulted prior to acceptance or purchase this building.
