DORIC PROPERTY INSPECTIONS

Confidential Inspection Report
27 Renown Street
Moss Vale
NSW
28th February, 2019

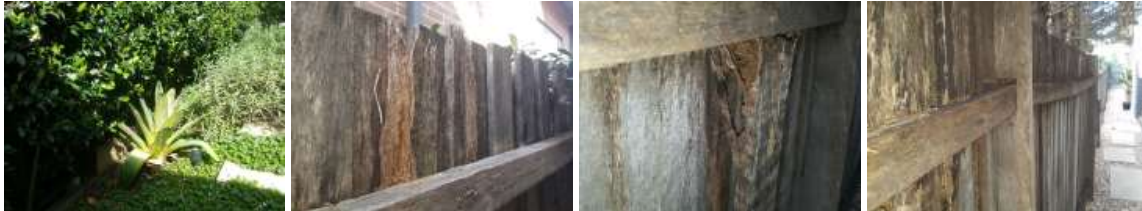
The inspection of the fencing timber was restricted by vegetation which will require removal to allow the fencing to be inspected.
Sections of the fencing is damaged requiring repairs carrying out.

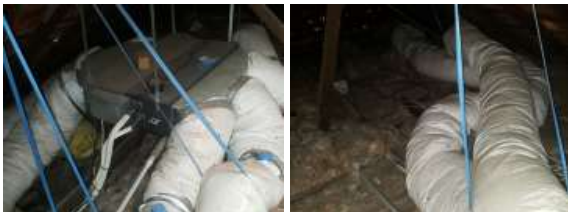
Restrictions: Ductwork and insulation is present in the roof cavity; this restricted inspection to the roof and ceiling timbers and removal of insulation or ductwork is not within the scope of a standard visual building inspection report.

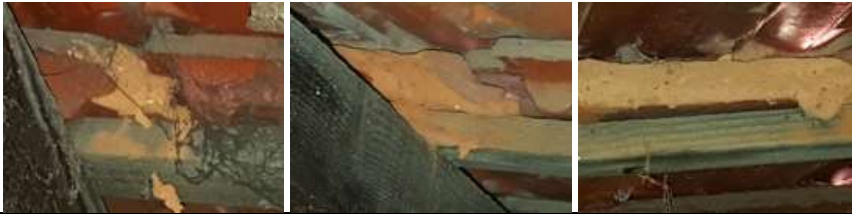
Evidence Of Tile Fretting: Major tile fretting was noted to terracotta tiles. This will continue to deteriorate and you should budget for their replacement in the short term.

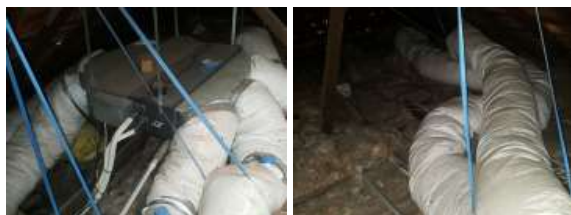
Ductwork and insulation is present in the roof cavity; this restricted inspection to the roof and ceiling timbers and removal of insulation or ductwork is not within the scope of a standard visual building inspection report.
