DORIC PROPERTY INSPECTIONS

Confidential Inspection Report
27 Renown Street
Moss Vale
NSW
28th February, 2019

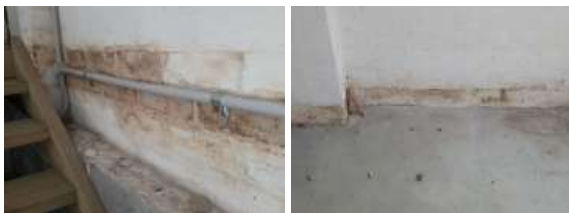
<i>Door/S</i>	The doors were tested and were in working order on inspection.
<i>Hard Floor Finishes</i>	The concrete flooring is in reasonable condition with no major defects visible.
<i>Wall Maintenance</i>	The walls to this area have high moisture readings and moisture damage which will require periodic maintenance repairs carrying out.
